**UNITED STATES ENVIRONMENTAL PROTECTION AGENCY
REGION 5
77 WEST JACKSON BOULEVARD
CHICAGO, ILLINOIS 60604**

SUBJECT: CLEAN AIR ACT INSPECTION REPORT
Waste Management – Prairie Hill Landfill, Morrison, Illinois

Facility Name: Prairie Hill Landfill
Facility Location: 18762 Lincoln Road, Morrison, IL 61270
Date of Inspection: June 2, 2021

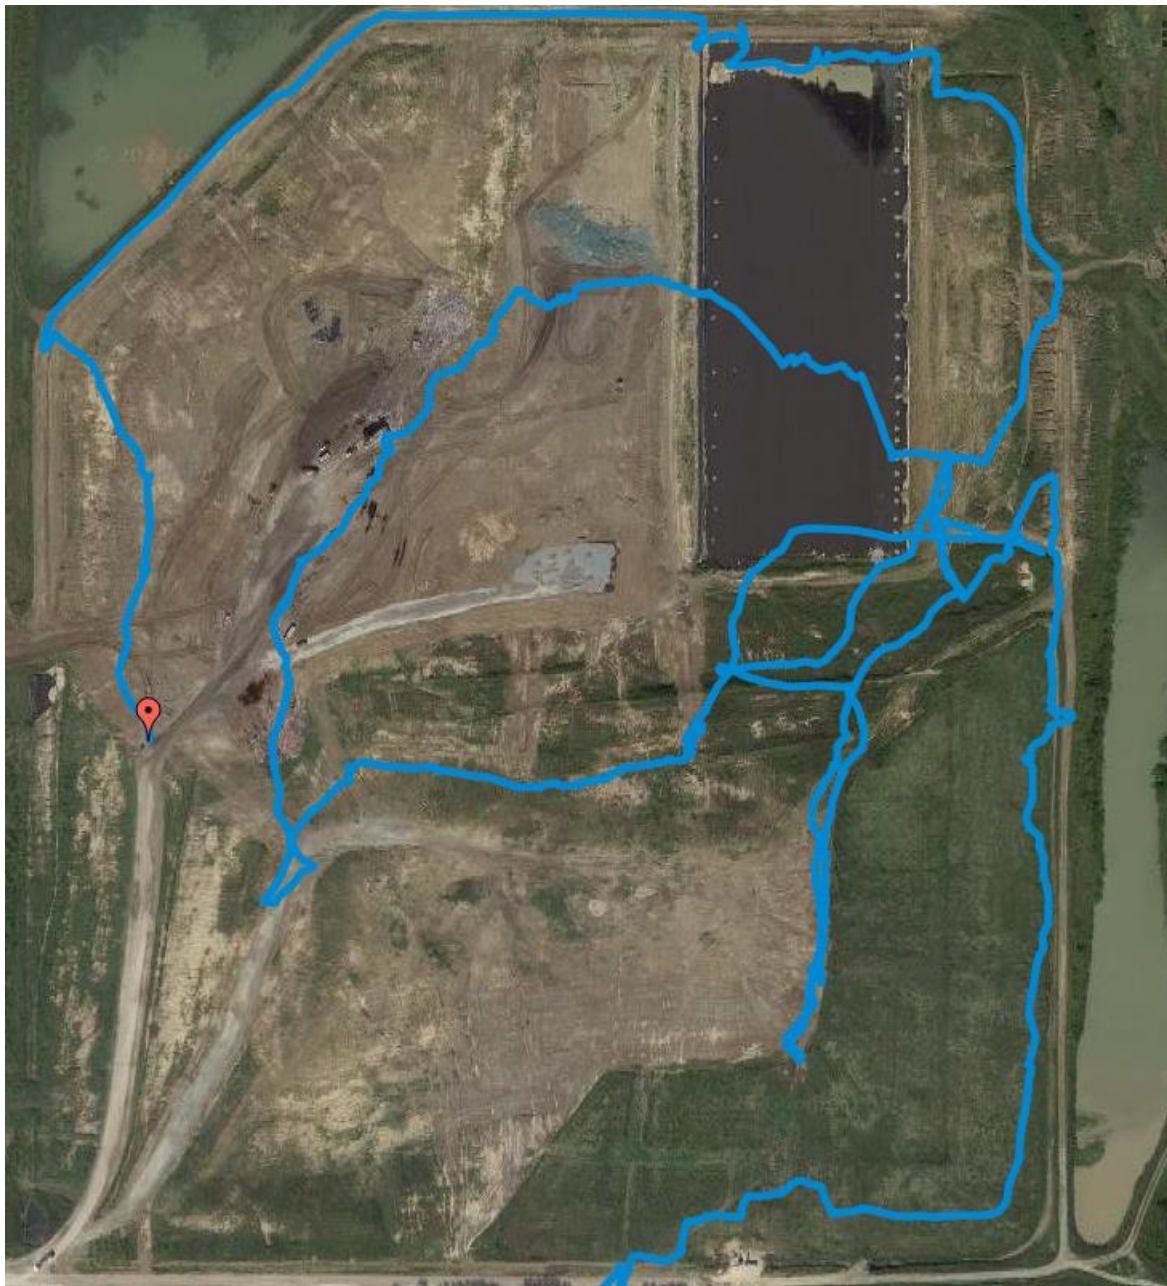
TVA #1 Comparative SEM Path Taken:
(Map data from Google Maps 2021)

Concerns: The SEM path that the EMT SEM technician traverses only covers the closed areas of the Landfill and at specific points in those areas. The technician relayed to EPA that this path and the points monitored are under the instruction of the previous Environmental Manager. The 51 exceedances that EPA detected and the observations listed in the above section, "Data Collected and Observations", are concerns.

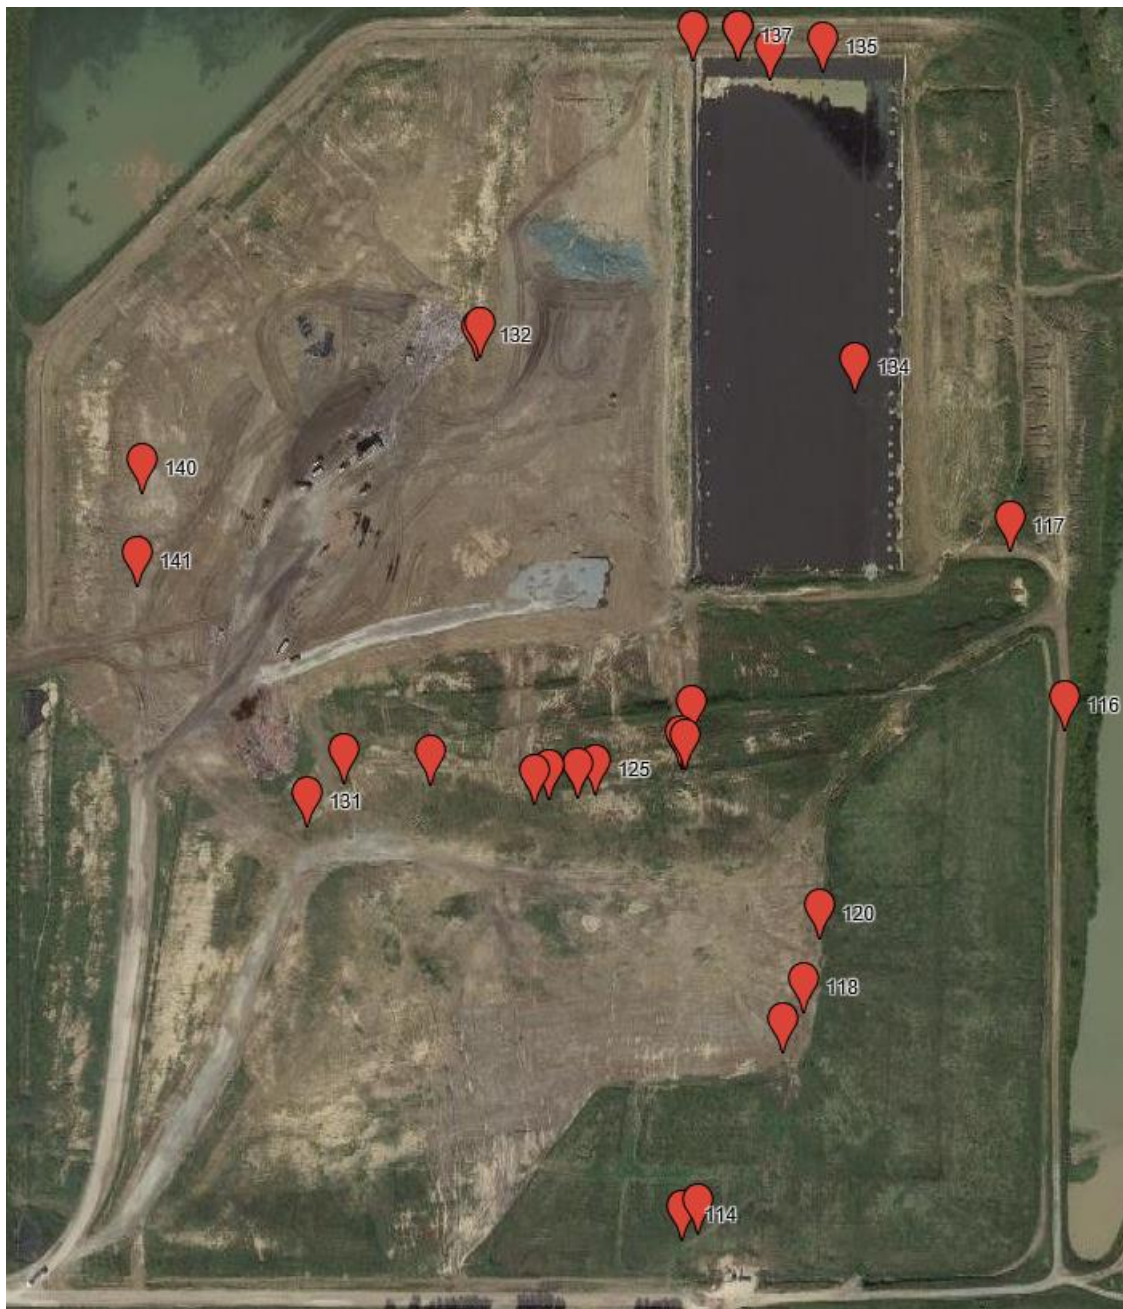
TVA #1 Exceedances Found:
(Map data from Google Maps 2021)

Exceedance Values						
Exceedance #	EPA GPS Waypoint #	Latitude	Longitude	EMT GPS Waypoint #	EPA Exceedance Reading (ppm)	EMT Exceedance Reading (ppm)
1	114 (TVA #1)	-89.8818	41.80189	436	1800	700
2	115	-89.8817	41.801918	437	8500	4370
3	87	41.8042	89.880774	443	670	7187
4	89	41.80506	89.879958	445	1300 (and 1300 with EPA TVA #2)	763
5	117 (TVA #1)	-89.8796	41.805322	448	2100 (and 2500 with EPA TVA #2)	1106
6	90	41.80514	89.880042	446	1700	919
7	105	41.80457	89.880707	444	1600 (and 1000 with EPA TVA #2)	1431
8	Location of GW-408.			441	3300	983

9	118 (TVA #1)	-89.881	41.803023	440	1000 (and 2000 with EPA TVA #2)	1150
10	119 (TVA #1)	-89.8811	41.802821	439	1000	1.24%
11	106	41.80271	-89.88106	438	6000	5092
12	120 (TVA #1)	-89.8809	41.803394	442	600	1312
13	108	41.80541	-	447	540	771
14	121 (TVA #1)	-89.8817	41.804404	449	700	1047
15	122 (TVA #1)	-89.8818	41.804242	451	5%	9.99% (flamed out)
16	123 (TVA #1)	-89.8818	41.804251	450	2800	2.84%
17	124	-89.8818	41.804239	452	1%	2.57%
18		41.80392	89.88187	453	3600	1.94%
19	125	-89.8824	41.804111	454	1300	1451
20	126	-89.8825	41.804091	455	644	722
21	109	41.80391	-	457	1.30%	8.74%
22	127 (TVA #1)	-89.8827	41.804084	456	9800	0.83%
23	128 (TVA #1)	-89.8828	41.804066	458	1400	2250.00%
24	129 (TVA #1)	-89.8835	41.804156	459	1200	1.13%
25	110	41.80395	-	460	3000	5430
26	111	41.80395	-	461	1300	674
27	130	-89.8841	41.804165		790	Not confirmed.
28	131	-89.8843	41.803953	462	1200	1389
29	112	41.80359	-	463	1400	1026

30	113	41.80376	-	464	2000	4139
31	132	-89.8832	41.806275	465	670	812
32	133	-89.8832	41.80629	466	1500	2537
33		41.8068	89.88263	467	2300	1704
34	114 (TVA #2)	41.80716	-	468	1400	1486
35	117 (TVA #2)	41.80645	-	469	1054	1798
36	118 (TVA #2)	41.80747	-	470	5%	9.90%
37	135	-89.8809	41.80772	471	5000	3441
38	119 (TVA #2)	41.8074	-	473	1600	992
39	137	-89.8814	41.807771	472	2400	2276
40	138	-89.8814	41.807774	475	1500	3781
41	120 (TVA #2)	41.80744	-	476	3200	2931
42	121 (TVA #2)	41.80737	-	474	2000	1870
43	139	-89.8817	41.807776	477	513	894
44	122 (TVA #2)	41.8074	-89.88254	478	820	1112
45	Location of GW-53.			479	1900	3938
46	123 (TVA #2)	41.80617	-	480	2%	1.26%
47	127 (TVA #2)	41.8059	-	481	1501	1543
48	140	-89.8854	41.805614	482	700	721
49	141	-89.8854	41.80515	484	2200	9.99% (flamed out)
50	128 (TVA #2)	41.80539	-	483	2.50%	3.75%
51	129 (TVA #2)	41.80465	-	485	2.20%	1.43%

Exceedance Descriptions		
Exceedance #	Location Description	Observations
1	75 ft West of flare; 50 ft North from road; 90 ft downslope South of GW-23.	Dead vegetation at toe of landfill.
2	20 ft East of Waypoint #114.	Elevated measurements and exceedances found within 20 ft radius.
3		Dead vegetation.
4	50 ft downslope Southeast of GW-70.	Erosion.
5	30 ft North of BC5.	Dead vegetation.
6	GW-70.	Erosion.
7	85 ft North of GW-22R.	Erosion.
8	GW-408.	
9	30 ft West of GW-408.	
10	40 ft upslope of GW-407.	No vegetation.
11	GW-407.	
12	Between GW-407 and GW-406.	
13	110 ft North of GW-70; 100 ft upslope of BC5; in between GW-70 and GW-69.	Erosion trench.
14	GW-406.	
15	50 ft South of GW-406; South of fill area.	Bubbling leachate with audible gas escaping from huge hole. Huge area of side slope with exposed waste and leachate seeps.
16	50' S. of GW-406; South of fill area.	Leachate seep with audible bubbling in another huge hole.

17	50' S. of GW-406; South of fill area.	Audible bubbling in another nearby hole. Whole side of slope with leachate filled holes and elevated methane readings and exceedances within 20 ft radius.
18	Distressed veg + leachate stain/washout	
19	Between GW-406 and GW-33.	
20	10' from EPA Waypoint #125.	
21		Leachate and distressed vegetation.
22	GW-33.

23	20' W. of GW-33.	Many exceedances detected within 40 ft radius of GW-33.
24	Between GW-33 and GW-41.	Exceedance in hole.
25	20' W. of GW-34.	Cracks in washout.
26	40' uphill of GW-40.	Erosion.
27	GW-41.	
28	100' W. of GW-41.	Erosion trench.
29	GW-39.	
30	By the road.	Inactive area with uncovered waste.
31		
32		
33	In what appeared to be auto fluff (central area of top)	
34	HC19.	
35	East slope; 60' W. of GW-68.	Erosion.
36	100' uphill of Southeast Leachate Riser, hole in rivulet	
37		Erosion; elevated measurements within 10 ft radius.
38	30' E of W59 / north slope rivulet	
39	50' S. of road; 100' W. of Leachate-308.	
40	150 ft West of Leachate-308; 50 ft upslope from road on North slope.	
41	Rivulet 40' W of W59	
42	Well 59 (in rivulet)	
43	30' upslope from road and GV-17.	Dried discolored leachate seep.
44	By the exposed mattress immediately beside W58	
45	GW-53.	Strong gas odor.
46	Well 49	
47	Well 52	
48	Unmarked gas well; 100 ft South of GW-52 on West slope.

49	GW-47.	
50	Well 51	
51	Well 50
